State Route 530

SR 530 Landslide Impact Area

06/11/2014

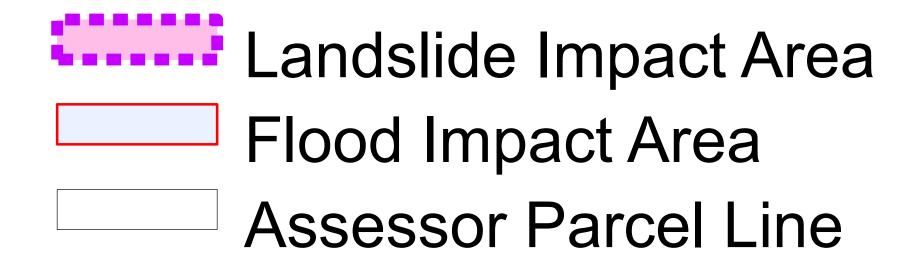
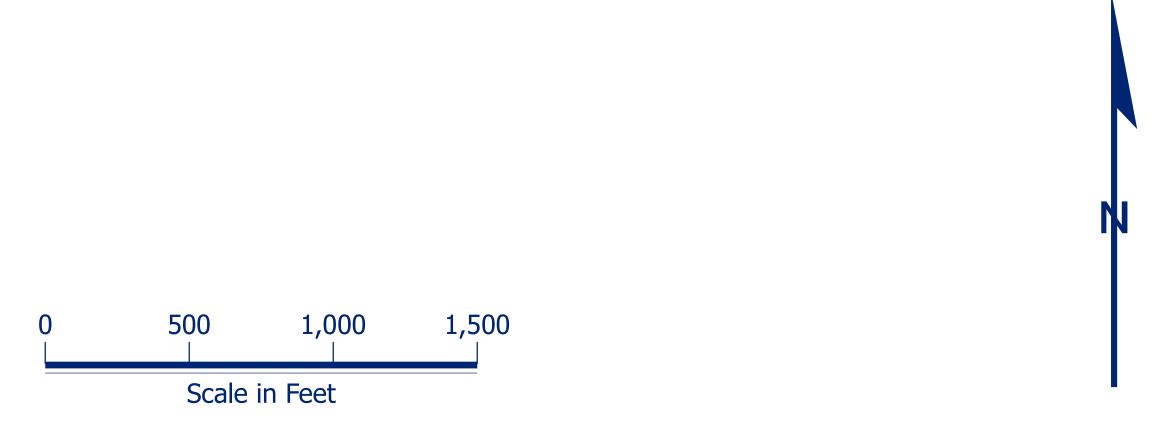
Post Landslide Aerial Image 05-2014

Landslide Impact Area was delineated by Snohomish County Staff and incorporated LiDAR data, aerial photography, and ground photography/review collected April and May 2014.

Flood Impact Area boundaries are based on a simulation of 100-year flow through a hydraulic river model (HEC-RAS) produced by FEMA with support from USACE that reflects the river conditions as of May 15, 2014.

Map extent depicts areas that represent significant deviation from the current Flood Insurance Rate Map Index 53061 CINDOA, Sept. 16, 2005. The SR 530 Flood Impact Area only includes those areas shown within the map extent.
